**VALLE ESCONDIDO CLUBHOUSE
DECK IMPROVEMENT
PROPOSAL
OCTOBER 3, 2019**

Proposed Design

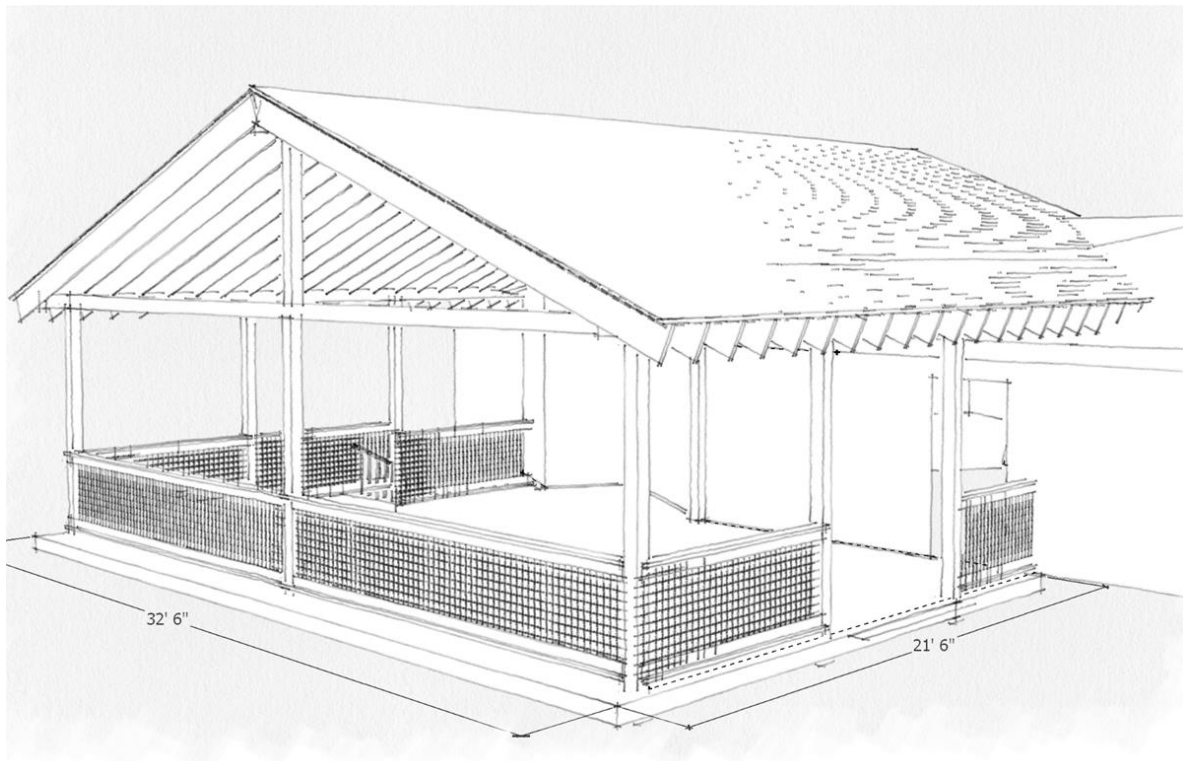
Figure 1-Valle Escondido Patio Addition

The proposed clubhouse improvement is shown in Figure 1. For a collection

of various views of the structure from additional perspectives, please reference Appendix III.

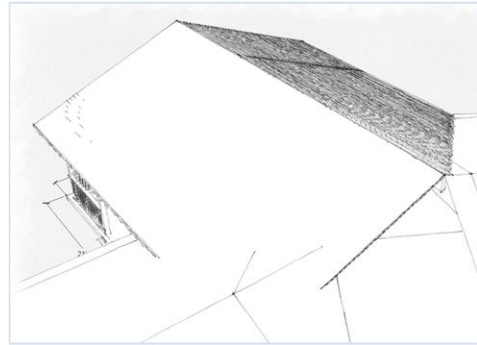
Figure 2 Roof Intersection with Clubhouse

The overall patio space will be expanded to 21.5' x 32.5' (appr 700 ft²). It will be oriented perpendicular to the original clubhouse structure. It is sufficiently wide to provide coverage of the main clubhouse entrance on the east side. On the west side it will provide weather coverage for a stair way to intersect with the existing stairway to the office and

maintenance shop. The depth of the addition will extend to the flower box near the first tee and will neither encroach on the existing tee box or the practice green. The center of the addition is aligned with the bend point in the current clubhouse structure. The center of the new roofline will intersect at the elevation and location of the northeast end of the clubhouse annex. (see figure 2)

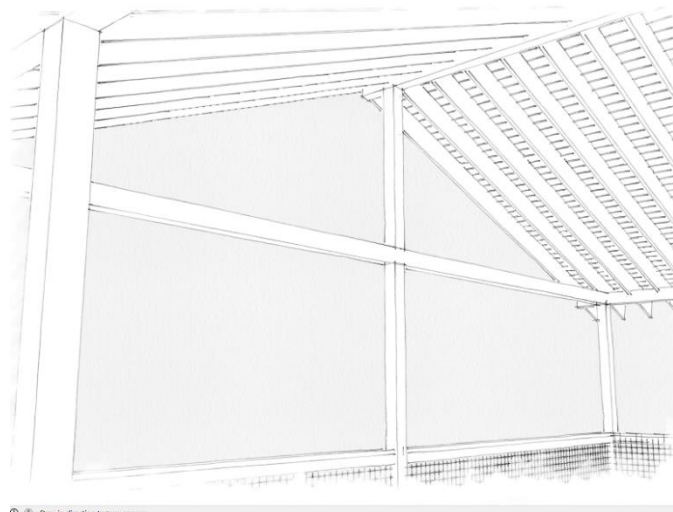
A gable roof design and post and beam structure were selected to maximize the panoramic views

available. See figure 3. trusses or a shed roof would severely limit the view. The design will incorporate exposed beams and posts to promote an outdoor airy and rustic appearance. Posts, beams and joists will

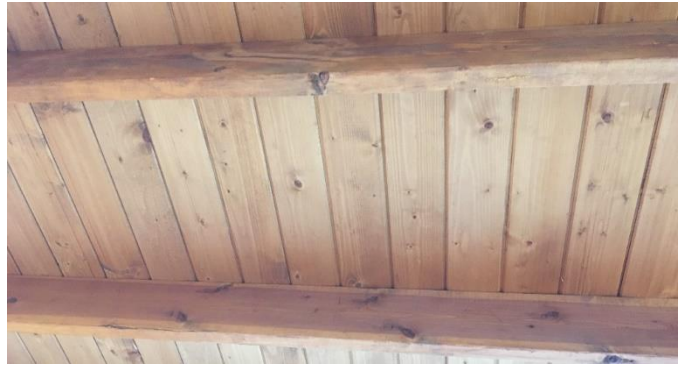
Figure 4 T&G Ceiling Fit and Finish

be stained wood. The roof decking will be tongue and groove pine as shown in Figure 4 .

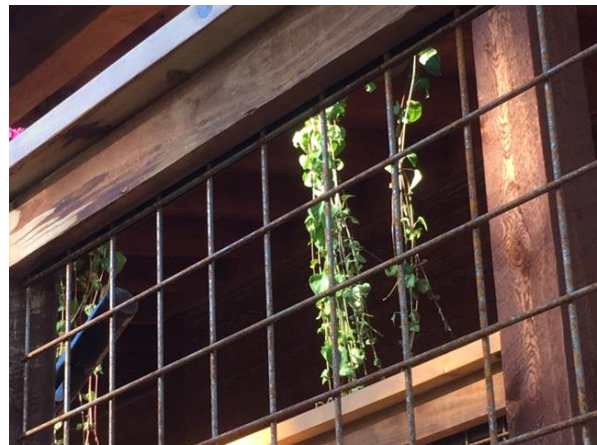
Figure 5 Steel Mesh Railing

A railing will encompass the complete perimeter of the new patio space to provide safety and comply with our liquor license requirements. The railing will be built with pressure treated lumber and stained. Instead of balusters, a ¼ inch steel mesh with a 4" square pattern will be used. Benefits of this choice include more transparent appearance as well as reduced maintenance. See Figure 5 for a view of this concept.

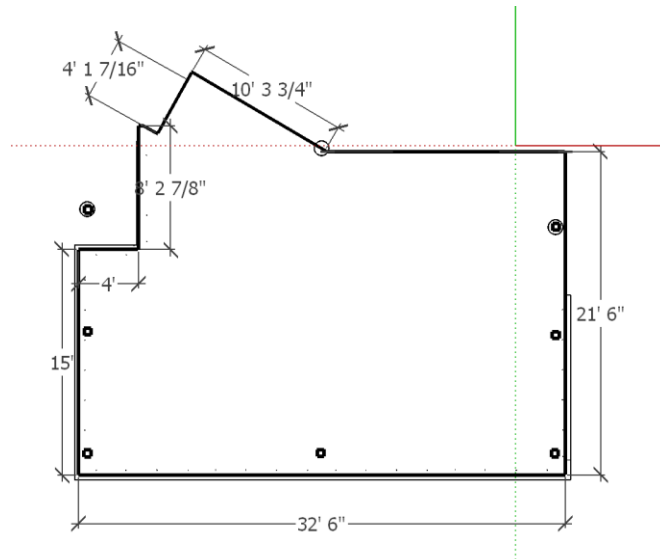
Figure 7 – Patio Floor plan

The patio surface will be a concrete slab surface at the grade level of the current sidewalk. This will be more durable and maintenance free than a raised wooden deck structure. The overall shape of the patio surface is as shown in Figure 7.

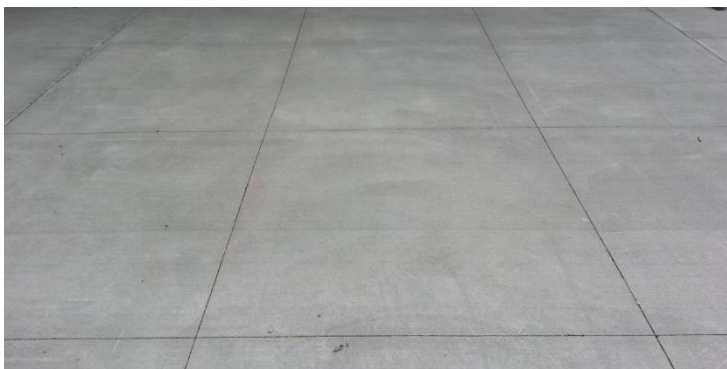
Figure 6 – Example of Saw Concrete Saw Cut Pattern

The surface of the patio will gray and be decorated with a sawcut pattern to provide

more visual appeal. See Figure 6 for an example. The foundation for the patio and roof structure will be provided by a combination of a stem wall around the perimeter of the patio surface and supplemented

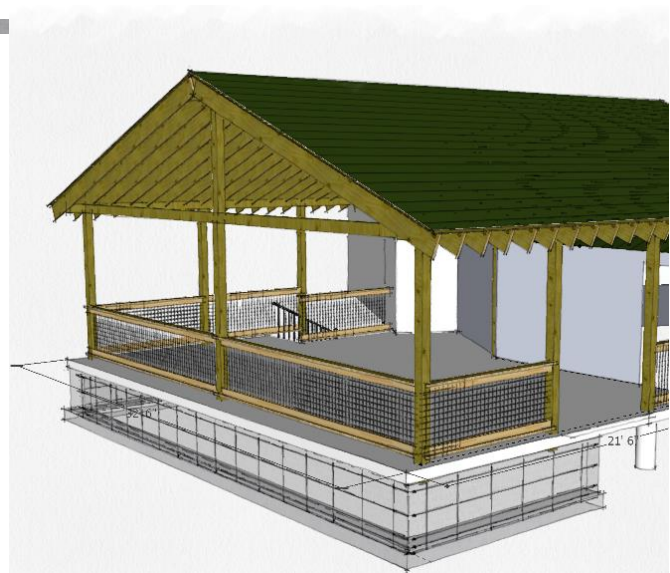
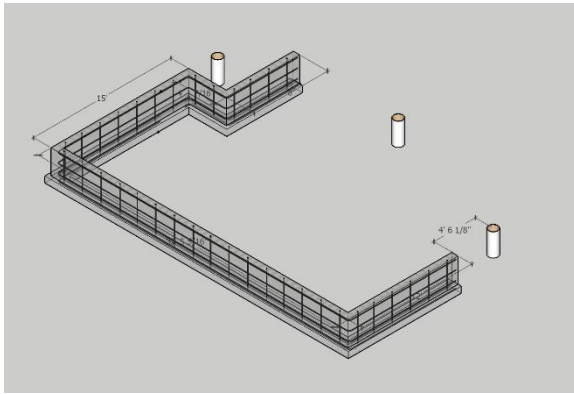
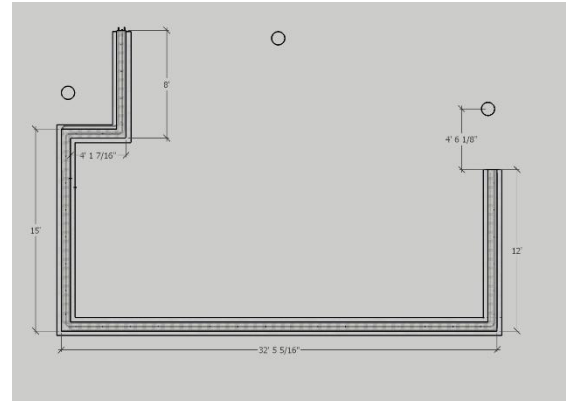
by concrete columns where required (3 locations). The enclosed area is to be backfilled with structural fill. The shape and location of key parts of the foundation system are shown in the following figures.

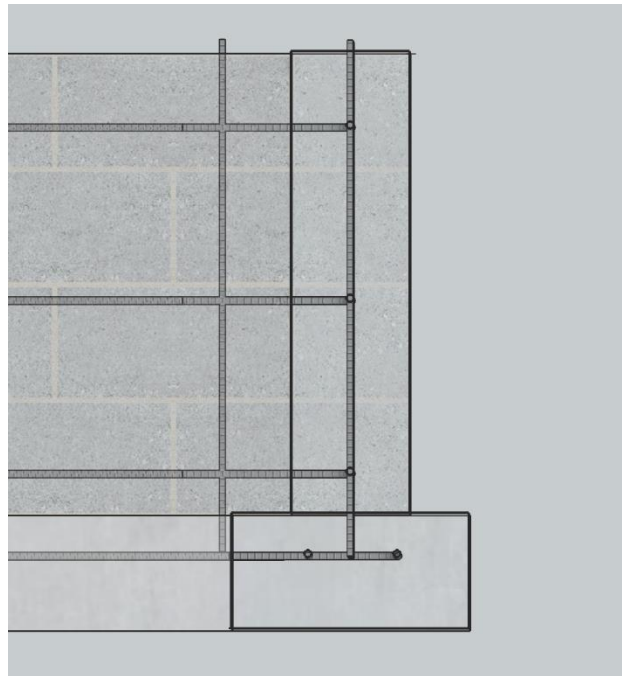
Figure 6 Foundation design

The stem wall will be a steel reinforced concrete structure. The design is shown in Figure 8. The footing will be 16" wide and 8" deep and run the full length of the wall. #4 rebar will be used for both horizontal and vertical reinforcement with vertical runs being 12" on center. The stem wall will rise 32" above the footing. The concrete surface will be 4" of 3000 psi concrete on compacted base material.

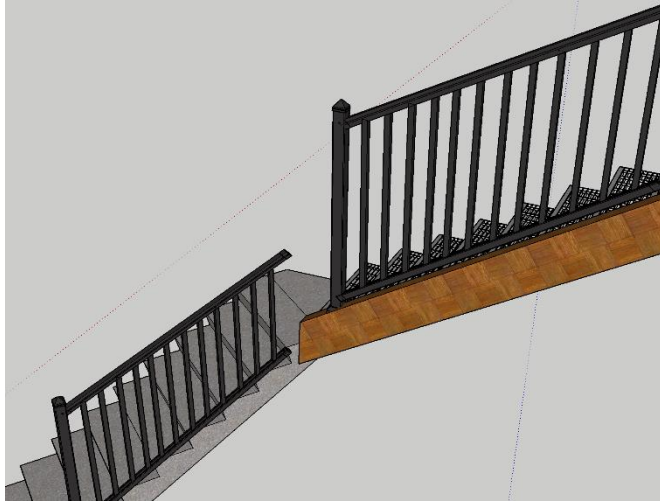
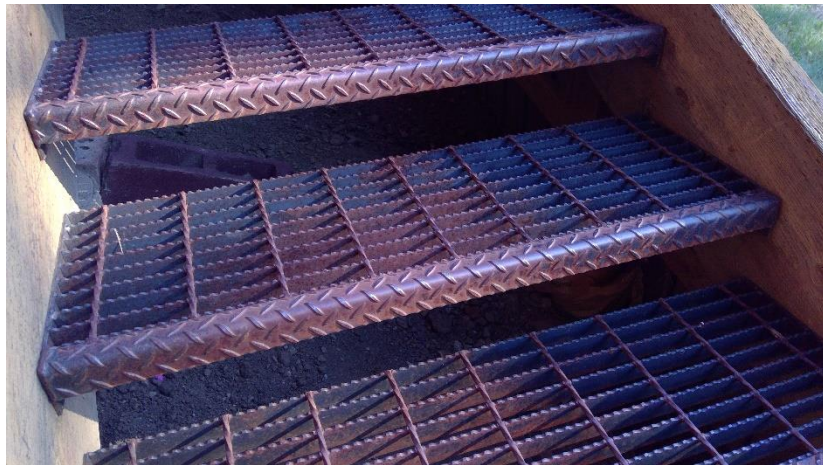
The upper portion of the existing stairway to the maintenance shop and office will be removed. A new flight of stairs will then be constructed under cover of the new roof structure. This flight will extend from the patio surface 8 steps to a concrete pad that intersects the remaining steps down to the office and shop area. The stairway will consist of serrated bar grate stair treads supported by a 4 x 12 timber on the outside and anchored to the stem wall (retaining wall) on the inside. See adjacent figures for an indication of the stairway configuration and to see the proposed stair tread material.

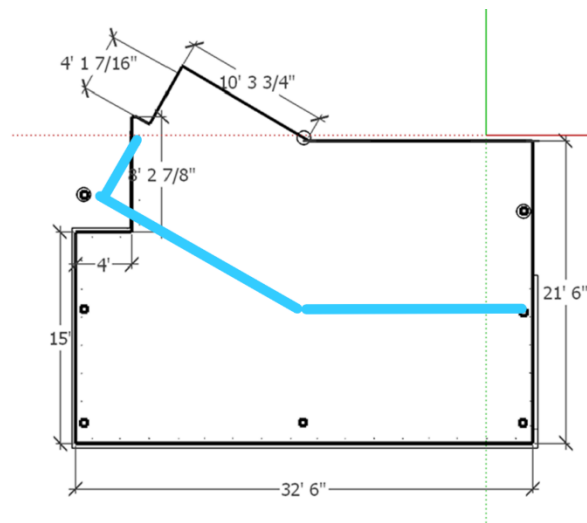
Our current liquor license will allow an increase in square footage up to 25% of our current footprint of 2844 sq. feet. The approved footprint includes the current deck and access area behind the fence. The adjacent figure shows the overlap of this

approved outdoor space and our proposed plan. The resulting net addition in our footprint will be approximately 400 square feet. This represents about 18% which is well under the allowed 25%. A request for approval will need to be submitted and received from the New Mexico Alcohol and Gaming Division. But the square footage is well under the 25 percent and should not be an issue.

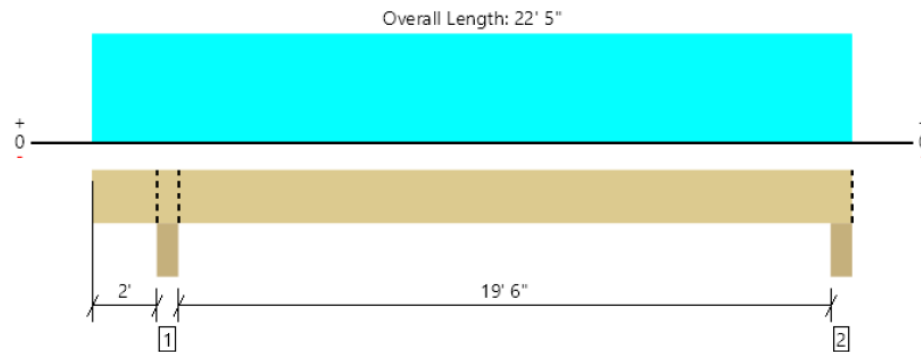
Roof, Ridge Beam
1 piece(s) 5 1/2" x 18" 24F-V4 DF Glulam

Design Results	Actual @ Location	Allowed	Result	LDF	Load: Combination (Pattern)
Member Reaction (lbs)	16857 @ 2' 2 3/4"	19663 (5.50")	Passed (86%)	--	1.0 D + 1.0 S (All Spans)
Shear (lbs)	11424 @ 3' 11 1/2"	20114	Passed (57%)	1.15	1.0 D + 1.0 S (All Spans)
Pos Moment (Ft-lbs)	66607 @ 12' 2 3/4"	65551	Passed (102%)	1.15	1.0 D + 1.0 S (Alt Spans)
Neg Moment (Ft-lbs)	-3410 @ 2' 2 3/4"	52656	Passed (6%)	1.15	1.0 D + 1.0 S (All Spans)
Live Load Defl. (in)	0.780 @ 12' 2 1/8"	0.993	Passed (L/305)	--	1.0 D + 1.0 S (Alt Spans)
Total Load Defl. (in)	0.979 @ 12' 2 3/16"	1.324	Passed (L/243)	--	1.0 D + 1.0 S (Alt Spans)

System : Roof
Member Type : Flush Beam
Building Use : Commercial
Building Code : IBC 2015
Design Methodology : ASD
Member Pitch : 0/12

- Deflection criteria: LL (L/240) and TL (L/180).
- Overhang deflection criteria: LL (2L/240) and TL (2L/180). Upward deflection on left cantilever exceeds overhang deflection criteria.

- Top Edge Bracing (Lu): Top compression edge must be braced at 6" o/c unless detailed otherwise.
- Bottom Edge Bracing (Lu): Bottom compression edge must be braced at 22' 5" o/c unless detailed otherwise.

The exterior surface of the roof will be covered with metal roofing in a color consistent with the current clubhouse roof. The sizing of the posts and beams are chosen to allow the structure to be supported on the perimeter. This was done to provide an open and flexible space on the patio surface. The Ridge beam will be a 5 ½" x 18" Glulam beam that spans between the front of the roof back to a post placed adjacent to the corner of the existing clubhouse structure. The drop beams on the sides and front of the structure will be 6x8 Fir beams supported by intermediate posts on the perimeter of the structure. Joists will be 2 x 12 conventional lumber. Posts will be 6x6 and pressure treated. The majority of the roof loads will be carried by the new construction to avoid stressing the existing clubhouse structure. Appendix I includes the structural component sizing analysis of the key components of the design.

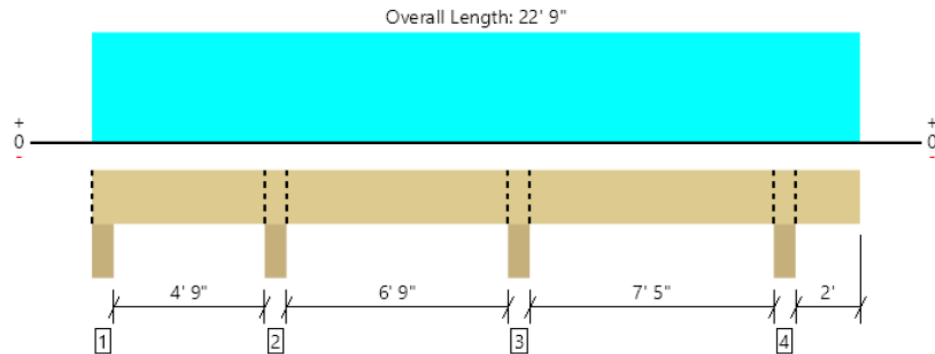
Roof, Bottom Left Beam

1 piece(s) 6 x 8 Douglas Fir-Larch No. 1

Design Results	Actual @ Location	Allowed	Result	LDF	Load: Combination (Pattern)
Member Reaction (lbs)	7074 @ 12' 7 3/4"	18906 (5.50")	Passed (37%)	--	1.0 D + 1.0 S (Adj Spans)
Shear (lbs)	3024 @ 13' 6"	5376	Passed (56%)	1.15	1.0 D + 1.0 S (Adj Spans)
Moment (Ft-lbs)	-5019 @ 12' 7 3/4"	5930	Passed (85%)	1.15	1.0 D + 1.0 S (Adj Spans)
Live Load Defl. (in)	0.098 @ 16' 9 11/16"	0.394	Passed (L/966)	--	1.0 D + 1.0 S (Alt Spans)
Total Load Defl. (in)	0.115 @ 16' 9 3/4"	0.525	Passed (L/820)	--	1.0 D + 1.0 S (Alt Spans)

System : Roof
Member Type : Drop Beam
Building Use : Commercial
Building Code : IBC 2015
Design Methodology : ASD
Member Pitch : 0/12

- Deflection criteria: LL (L/240) and TL (L/180).
- Overhang deflection criteria: LL (2L/240) and TL (2L/180).
- Top Edge Bracing (Lu): Top compression edge must be braced at 22' 9" o/c unless detailed otherwise.
- Bottom Edge Bracing (Lu): Bottom compression edge must be braced at 22' 9" o/c unless detailed otherwise.
- Applicable calculations are based on NDS.

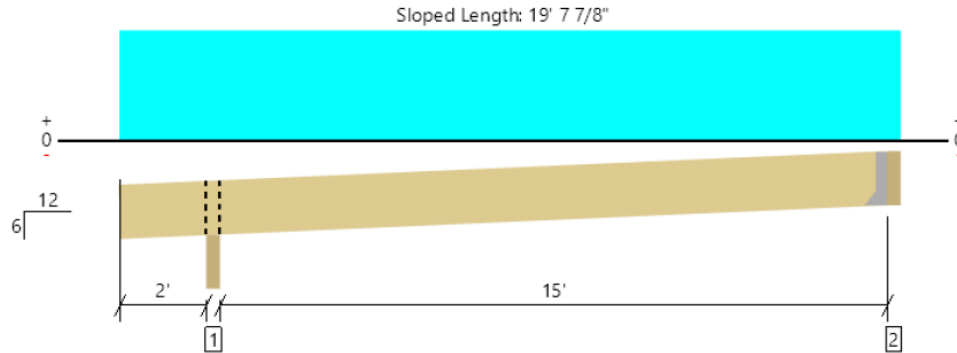
Roof, Roof: Joist

1 piece(s) 2 x 12 Douglas Fir-Larch No. 1 @ 16" OC

Member Length : 19' 9 5/8"

Design Results	Actual @ Location	Allowed	Result	LDF	Load: Combination (Pattern)
Member Reaction (lbs)	866 @ 17' 3 1/2"	1406 (1.50")	Passed (62%)	--	1.0 D + 1.0 S (Alt Spans)
Shear (lbs)	780 @ 3' 1 9/16"	2329	Passed (33%)	1.15	1.0 D + 1.0 S (All Spans)
Moment (Ft-lbs)	3238 @ 9' 9 11/16"	3487	Passed (93%)	1.15	1.0 D + 1.0 S (Alt Spans)
Live Load Defl. (in)	0.446 @ 9' 8 15/16"	0.564	Passed (L/456)	--	1.0 D + 1.0 S (Alt Spans)
Total Load Defl. (in)	0.550 @ 9' 9"	0.847	Passed (L/370)	--	1.0 D + 1.0 S (Alt Spans)

System : Roof
 Member Type : Joist
 Building Use : Commercial
 Building Code : IBC 2015
 Design Methodology : ASD
 Member Pitch : 6/12

- Deflection criteria: LL (L/360) and TL (L/240).
- Overhang deflection criteria: LL (2L/360) and TL (2L/240). Upward deflection on left cantilever exceeds overhang deflection criteria.
- Top Edge Bracing (Lu): Top compression edge must be braced at 3' o/c unless detailed otherwise.
- Bottom Edge Bracing (Lu): Bottom compression edge must be braced at 19' 4" o/c unless detailed otherwise.
- A 15% increase in the moment capacity has been added to account for repetitive member usage.
- Applicable calculations are based on NDS.

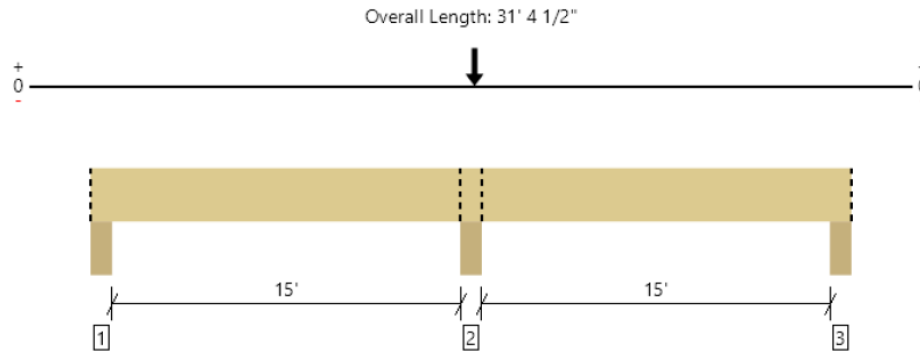
Roof, Roof: Drop Beam
1 piece(s) 6 x 8 Douglas Fir-Larch No. 1

Design Results	Actual @ Location	Allowed	Result	LDF	Load: Combination (Pattern)
Member Reaction (lbs)	17058 @ 15' 8 1/4"	18906 (5.50")	Passed (90%)	--	1.0 D + 1.0 S (All Spans)
Shear (lbs)	91 @ 16' 6 1/2"	4208	Passed (2%)	0.90	1.0 D (All Spans)
Moment (Ft-lbs)	-308 @ 15' 8 1/4"	4641	Passed (7%)	0.90	1.0 D (All Spans)
Live Load Defl. (in)	0.000 @ 0	0.768	Passed (2L/999+)	--	1.0 D (All Spans)
Total Load Defl. (in)	0.018 @ 6' 9 3/4"	1.024	Passed (L/999+)	--	1.0 D (All Spans)
